# Inspection Report

Permit Number:	C0150032
Inspection Type:	PARTIAL
Inspection Date:	Thursday, September 18, 2008
Start Date/Time:	9/18/2008 10:00:00 AM
End Date/Time:	9/18/2008 2:30:00 PM
Last Inspection:	Wednesday, September 03, 2008

Permittee: **GENWAL RESOURCES INC**  
 Operator: **GENWAL RESOURCES INC**  
 Site: **CRANDALL CANYON MINE**  
 Address: **PO BOX 1077, PRICE UT 84501**  
 County: **EMERY**  
 Permit Type: **PERMANENT COAL PROGRAM**  
 Permit Status: **ACTIVE**

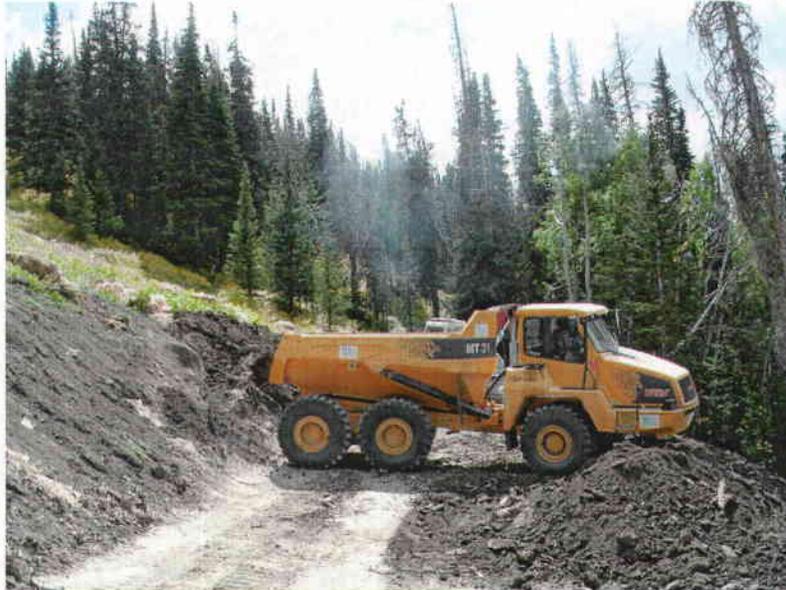
The access road has been reclaimed up to the elbow in the road between pads #6 and #2. Dark, rich topsoil material is being hauled by rock truck out of this bend in the road for use in reclaiming the upper access road, photo attached. The access road just above pad 6 should have excellent vegetation growth in comparison with pads #2 and #6, because of this growing medium. Soil from the berm along pad #2 was sampled during an earlier inspection and analyzed by Brigham Young University laboratory. The analysis of the clay subsoils that form the slopes of pads #2 and #6 is attached to this inspection report.

Rock truck moves rich soil to access road above pad #6

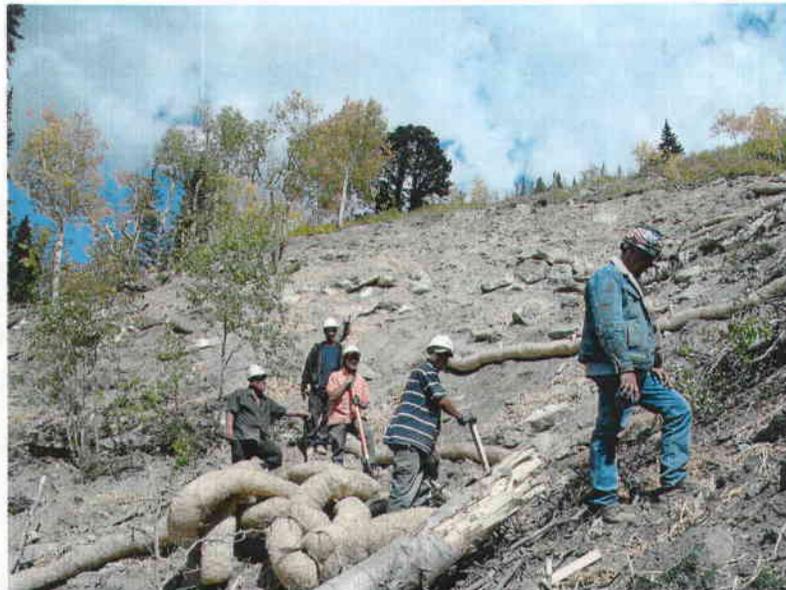
A natural channel begins on the slope east of pad 6. Excelsior logs were laid out in this location. We agreed that a series of three logs would treat the runoff coming onto the reclaimed access road and that a series of three more logs (top, middle, bottom of slope) would treat runoff from the reclaimed access road before the drainage reached the undisturbed slope above pad 6. We discussed placing excelsior logs every ten feet down the run of the pad 6 and "Oops" road reclaimed slope. A four man crew was on site installing these excelsior logs, see photo attached.

Excelsior Log Installation

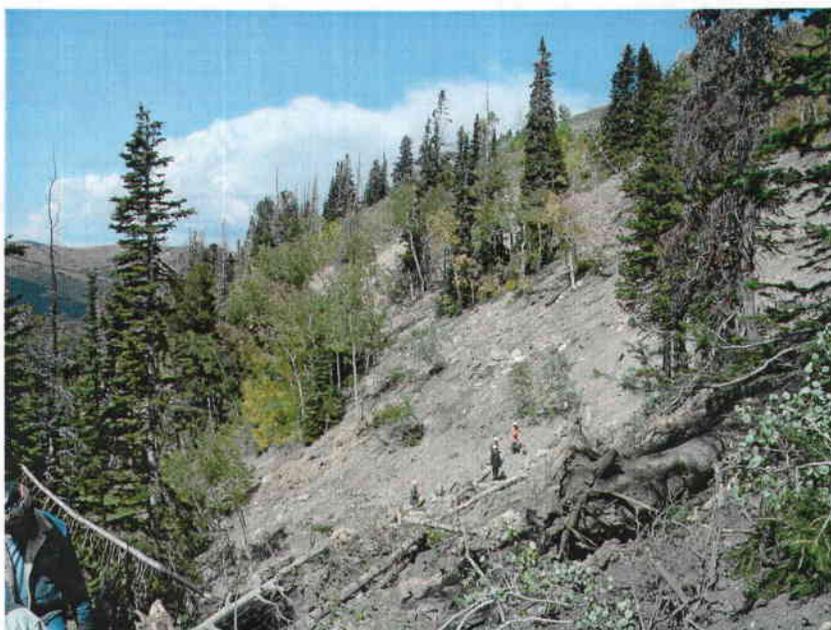
Approximately 9,000 cu yds of soil has been moved by the rock truck, more material will be moved today. This figure does not include the material transferred by two hoes. Pads 6 and 2 are backfilled to the level of the cut along most of their length. The cut slopes were not overfilled and some settling will likely reveal a bit of the cut slope, see attached photos. We discussed overfilling the cut slopes on the remaining reclamation along the access road. Overall, the reclaimed slopes meet the approximate original contour and the slopes of both pads blend together at cross section B-B' , at approximately 56% slope, 30 degrees or 1.34 h:1v, as illustrated on App. 5-22A, Attachment 13, Plates 1 and 3 of 7, see photo attached.

Slopes of Pad #2 and Pad #6 combine at approximately 1.75h:1v

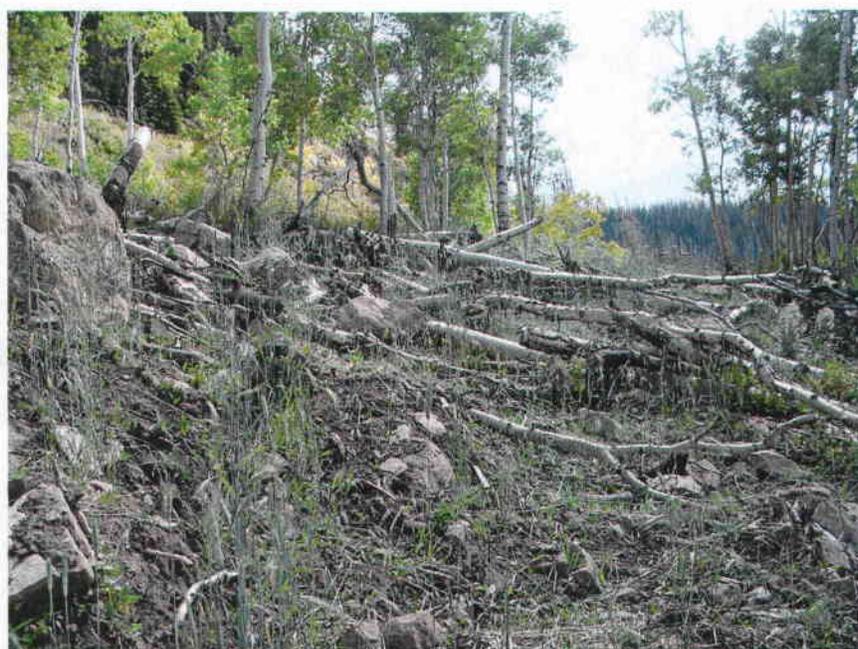
Areas that were seeded last year have very tall stands of Triticale (seed heads are about hip height). This sterile rye will not reproduce and will die back during the winter, producing a new layer of mulch, protecting the soil and trapping moisture for the understory of perennial grasses and forbes that are becoming established, see photo attached. We noted aspen and woods rose regeneration on the access road to pad #3. We noted slender wheatgrass and showy golden eye growing in the understory beneath the Triticale..

Revegetation on Pad #3

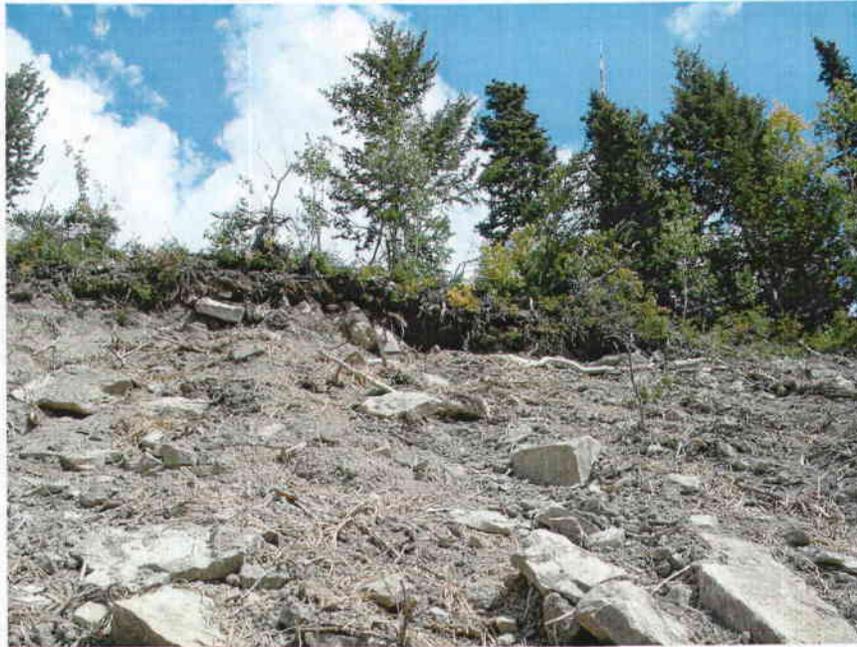
**Small segments of cut slopes remain**

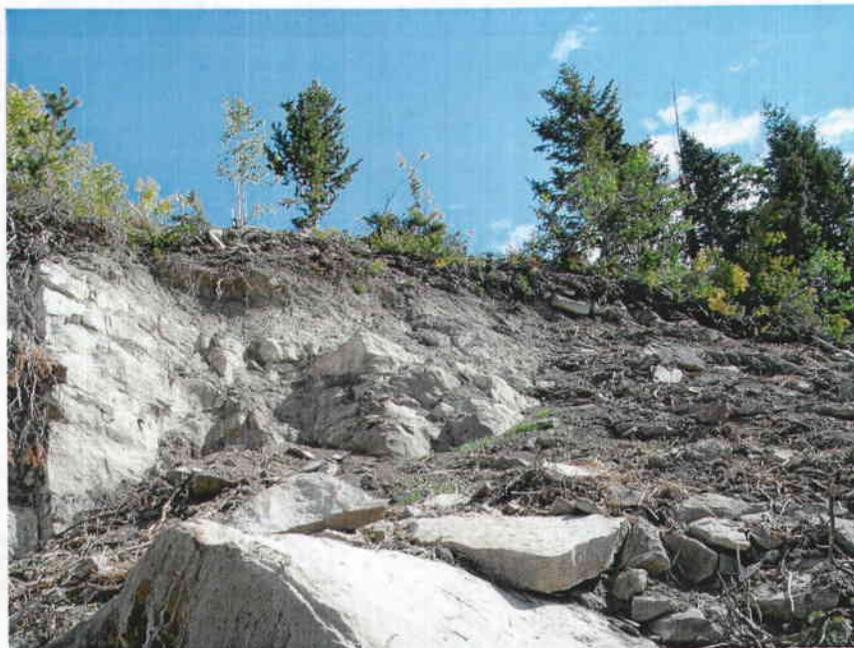
**Largest cut slope remaining near ledge shown on maps in Attachment #4.**
